SERIOUS INCIDENT

Aircraft Type and Registration:	1) Fuji FA-200-180 Aero Subaru, G-HAMI 2) Cessna 172R Skyhawk, G-BXGV
No & Type of Engines:	1) 1 Lycoming IO-360-B1B piston engine 2) 1 Lycoming IO-360-L2A piston engine
Year of Manufacture:	1) 1973 (Serial no: FA200-188) 2) 1997 (Serial no: 17280240)
Date & Time (UTC):	23 June 2019 at 0955 hrs
Location:	Near Henley-on-Thames, Oxfordshire
Type of Flight:	1) Private 2) Private
Persons on Board:	1) Crew - 1 Passengers - 2 2) Crew - 1 Passengers - 3
Injuries:	1) Crew - None Passengers - None 2) Crew - None Passengers - None
Nature of Damage:	1) None 2) Damage to right wingtip
Commander's Licence:	1) Private Pilot's Licence 2) Private Pilot's Licence
Commander's Age:	1) 68 years 2) 76 years
Commander's Flying Experience:	1) 531 hours (of which 322 were on type) Last 90 days - 5 hours Last 28 days - 5 hours 2) 890 hours (of which 830 were on type) Last 90 days - 6 hours Last 28 days - 1 hour

Synopsis

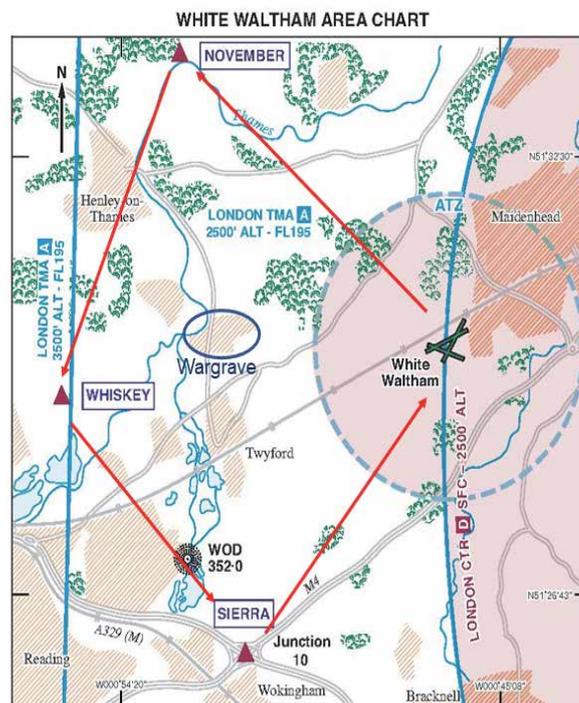
Figure 1

Briefed routing of flights

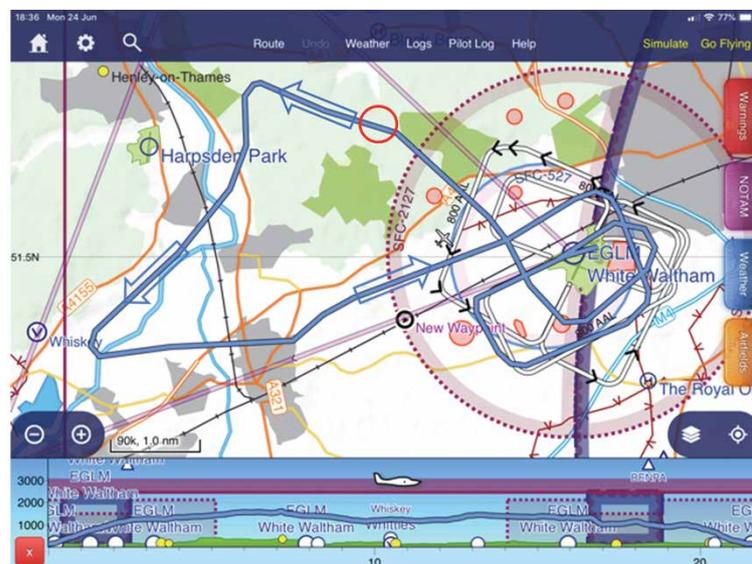
Figure 2

Once airborne the previously unsettled child became vocal. Fearing he may become physically disturbed again, the pilot decided to shorten the route by flying towards Henley-on-Thames, Oxfordshire. Shortly after leaving the Aerodrome Traffic Zone, while straight and level, the pilot noticed a bright red aircraft above, in his 8 o'clock position, converging on his aircraft. He then lost sight of it above and behind his aircraft's high-wing, becoming visual again when it was in his 1 to 2 o'clock position. It then was seen to descend before disappearing from his sight. He didn't have time to take avoiding action but filed an Airprox on White Waltham's A/G radio frequency. He continued the flight to Henley-on-Thames and Point Whiskey before returning to White Waltham without further event, landing at 1009 hrs (Figure 2).

G-BXGV's routing
(Red circle indicates approximate location of collision)

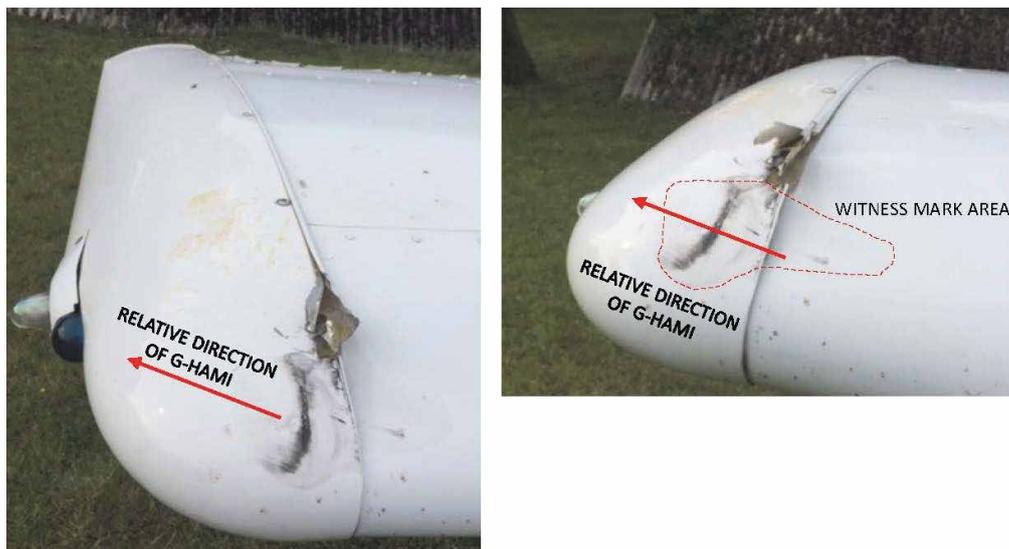
Figure 3

Both pilots then flew another flight without event. After landing, G-BXGV's pilot noticed damage to the aircraft's right wingtip (Figure 3). He then informed G-HAMI's pilot of it and that they must have collided in flight.

Damage to G-BXGV right wingtip

The damage to G-BXGV's right wingtip (Figure 3) was repaired soon after the accident and was not able to be examined by the AAIB. Analysis of the photographs indicated that the tyre of G-HAMI contacted the wing just inboard of the tip and moved outwards leaving the skid mark shown.
